BUSHFIRE ATTACK LEVEL

FOR
FUTURE DWELLINGS

AT STAGE 17
HERITAGE PARC ESTATE
RUTHERFORD

Site Details:	Stage 17 Heritage Parc Estate, Rutherford
Prepared by:	<i>Sarah Jones B.Env.Sc.,G.Dip.DBPA (Design in Bushfire Prone Areas)</i> <i>Firebird ecoSultants Pty Ltd</i> ABN – 16 105 985 993 PO Box 354, Newcastle NSW 2300 M: 0414 465 990 Email: sarah@firebirdeco.com.au T: 02 4910 3939 Fax: 02 4929 2727
Prepared for:	McCloy Group
Reference No.	Heritage Parc – McCloy Group
Document Status & Date:	September 2018

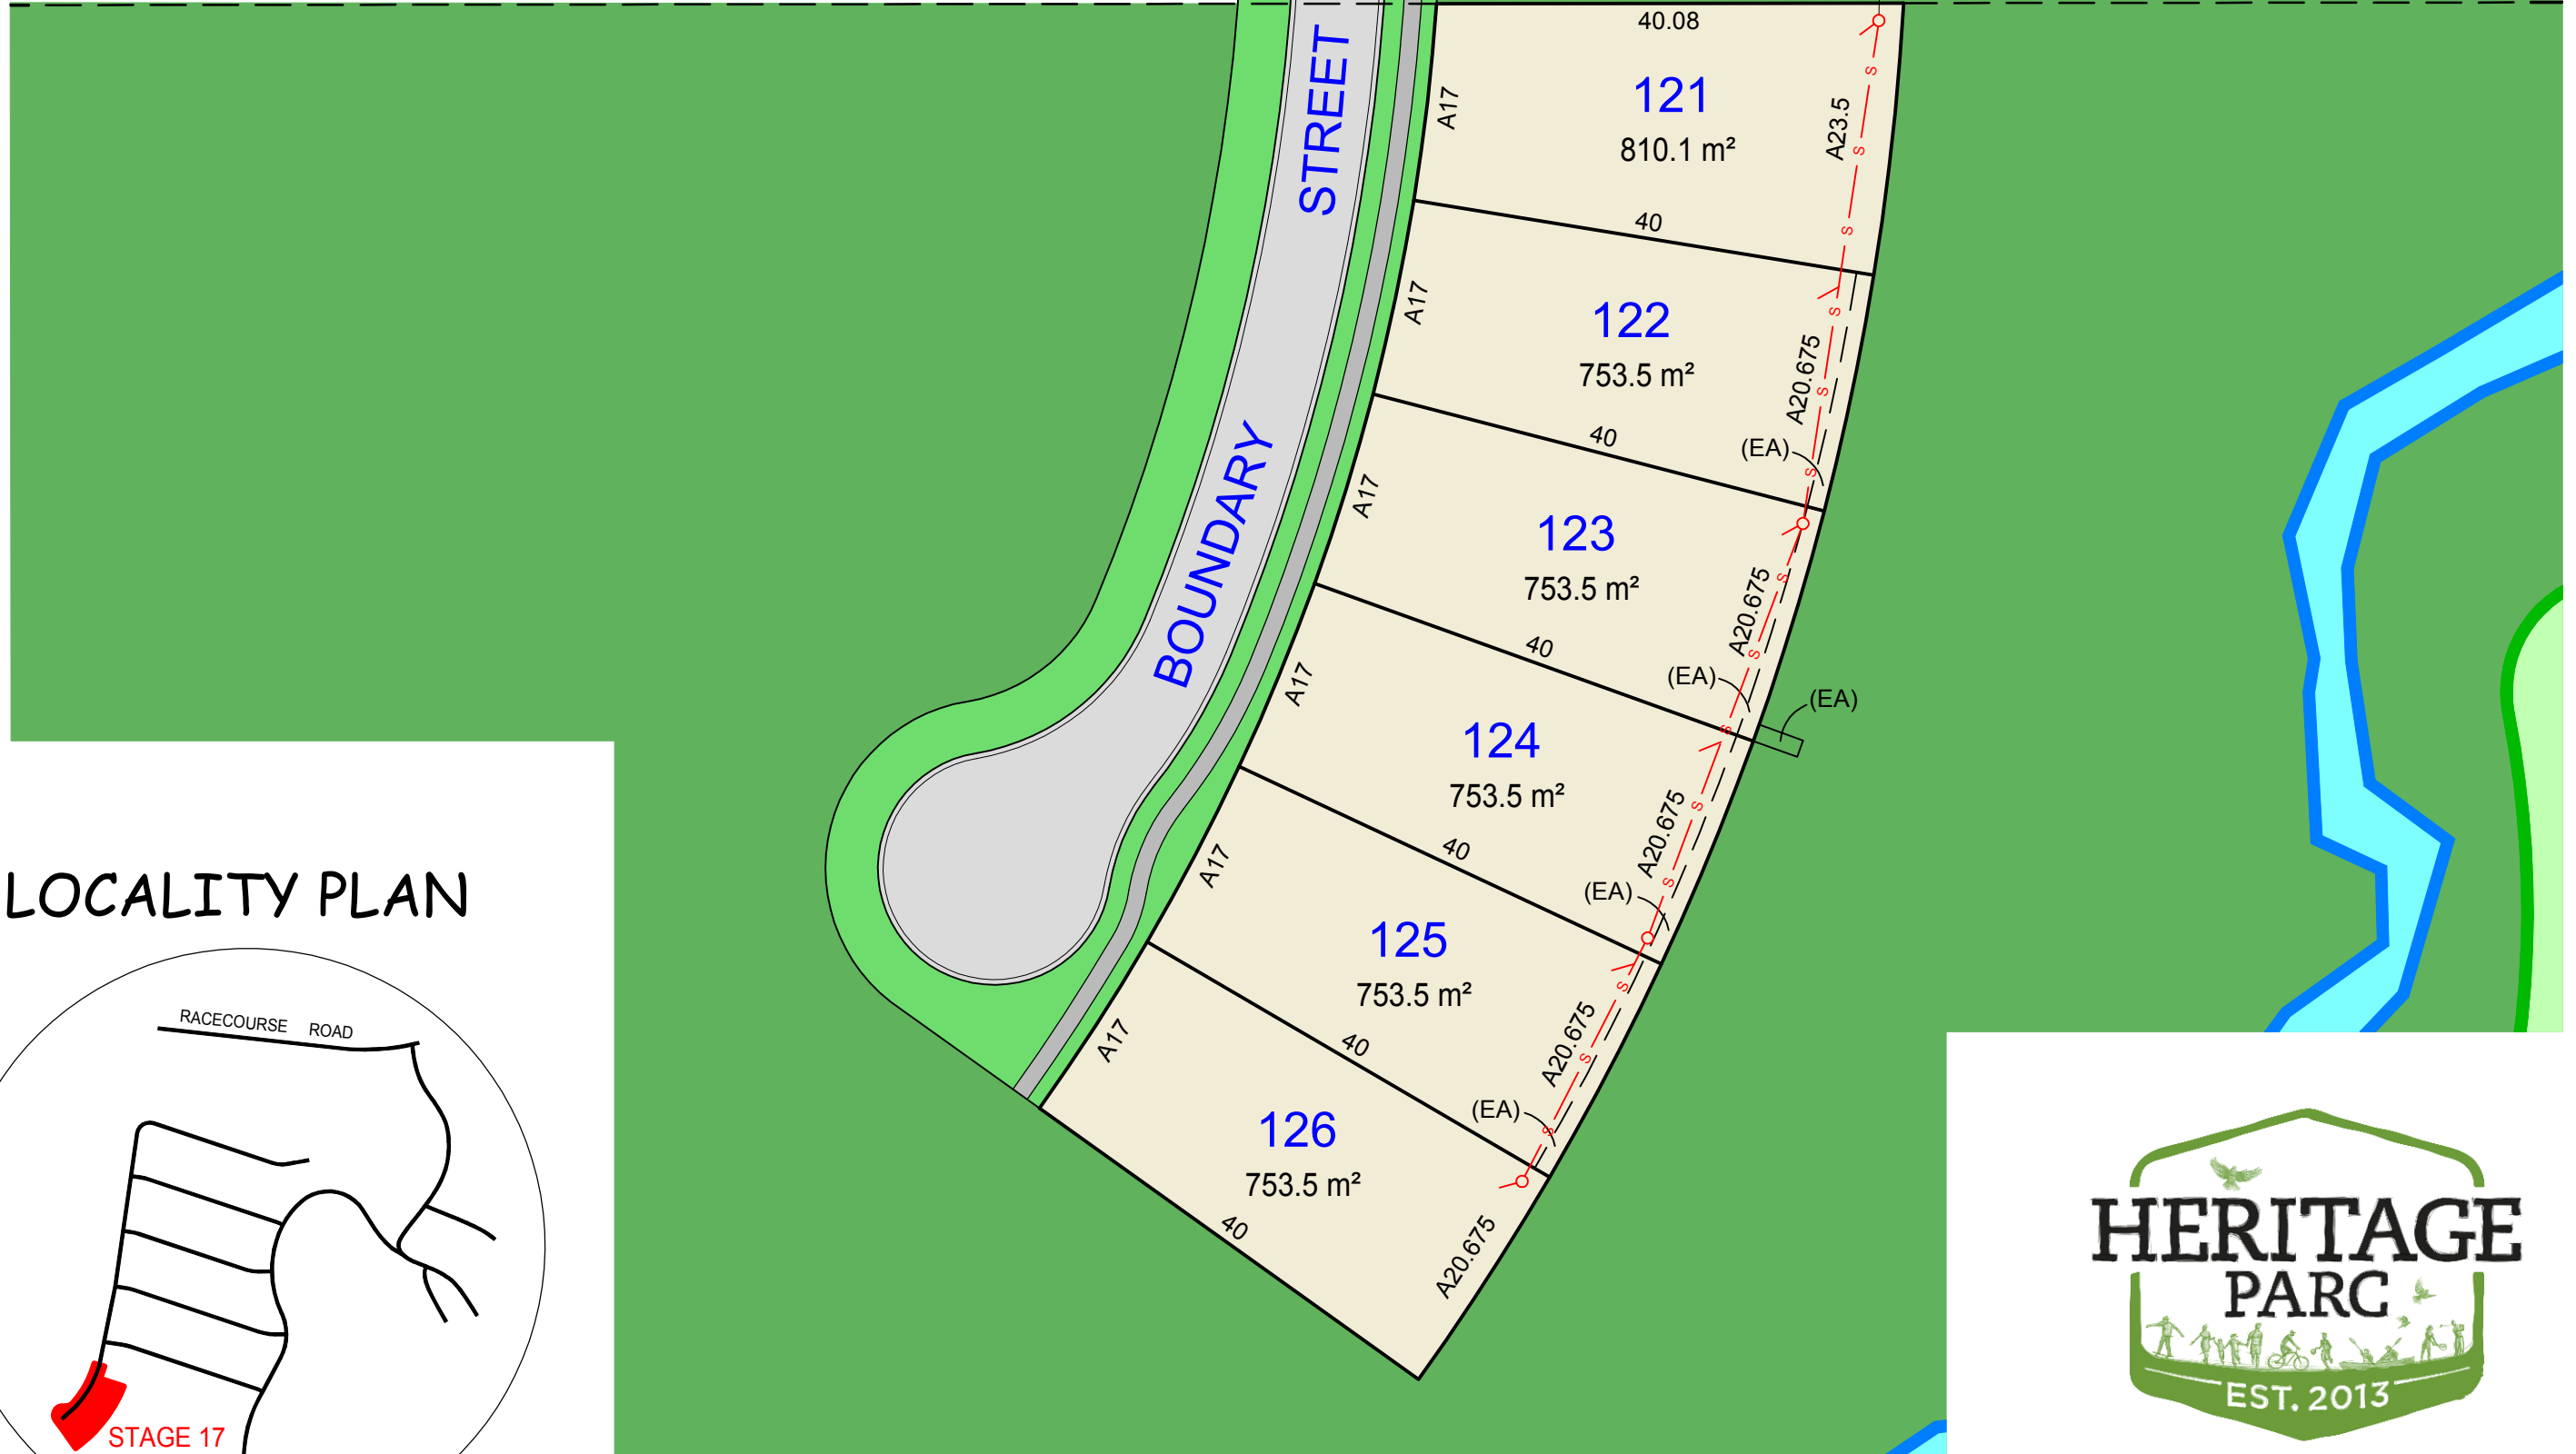
SALE PLAN FOR HERITAGE PARC STAGE 17

(C) EASEMENT FOR TRANSMISSION LINE 20.115 WIDE (F602288)
(EA) EASEMENT FOR DRAINAGE OF WATER 1.5 WIDE

— s — s — PROPOSED SEWER LINE

Firebird ecoSultants Pty Ltd has been engaged by McCloy Group Pty Ltd to undertake a Bushfire Attack Level (BAL) report for Stage 17 Heritage Parc Estate, Rutherford hereafter referred to as the “site”. Refer to Appendix A for Sales Plan.
